Icom 7610 Heat Sink, Loose or Detached ADC Heatsinks

Icom 7610 Heat Sink Photo

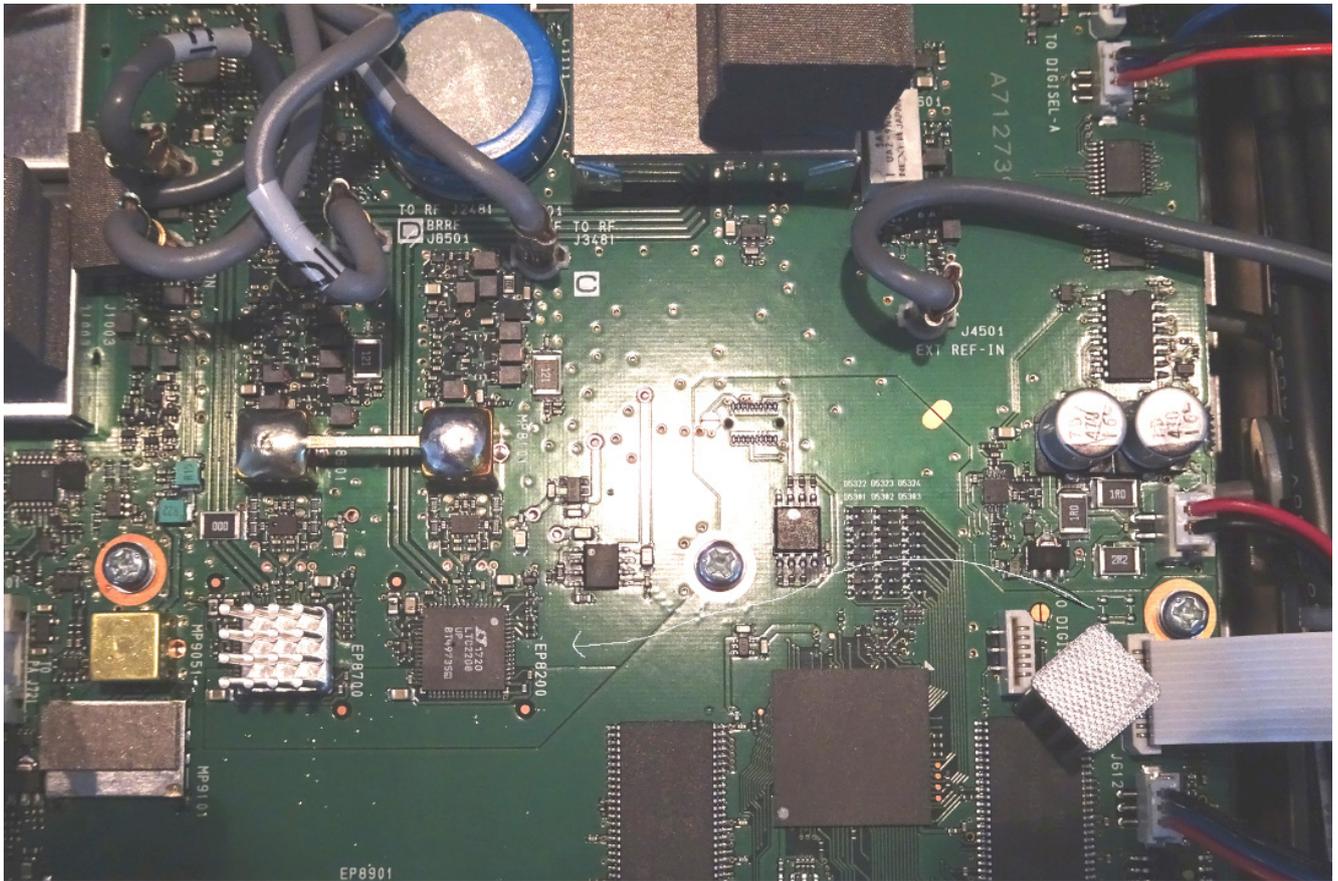
There's a new thread in the [Icom 7610 Groups.io](https://www.groups.io/g/Icom7610) forum discussing the Icom 7610 ADC heat sinks. Evidentially, during a production run, one or possibly two heat sinks were not held into place long enough for the adhesive to attach the heat sink securely. Some Icom 7610 owners have reported loose or detached heat sinks in the Icom 7610.

In this photo there is a heat sink that has come off of the chip EP8200.

If needed, reseal the heat sink (being careful not to touch a capacitor that is close to one corner of the ADC) and hold it down firmly in place for 30 seconds. That should fix it. Do not attempt to glue it with epoxy, Super-Glue, Loctite or any other non-heat-transferring material. Any such action will void the warranty. Please visit the Icom 7610 Groups.io forum for more direction.

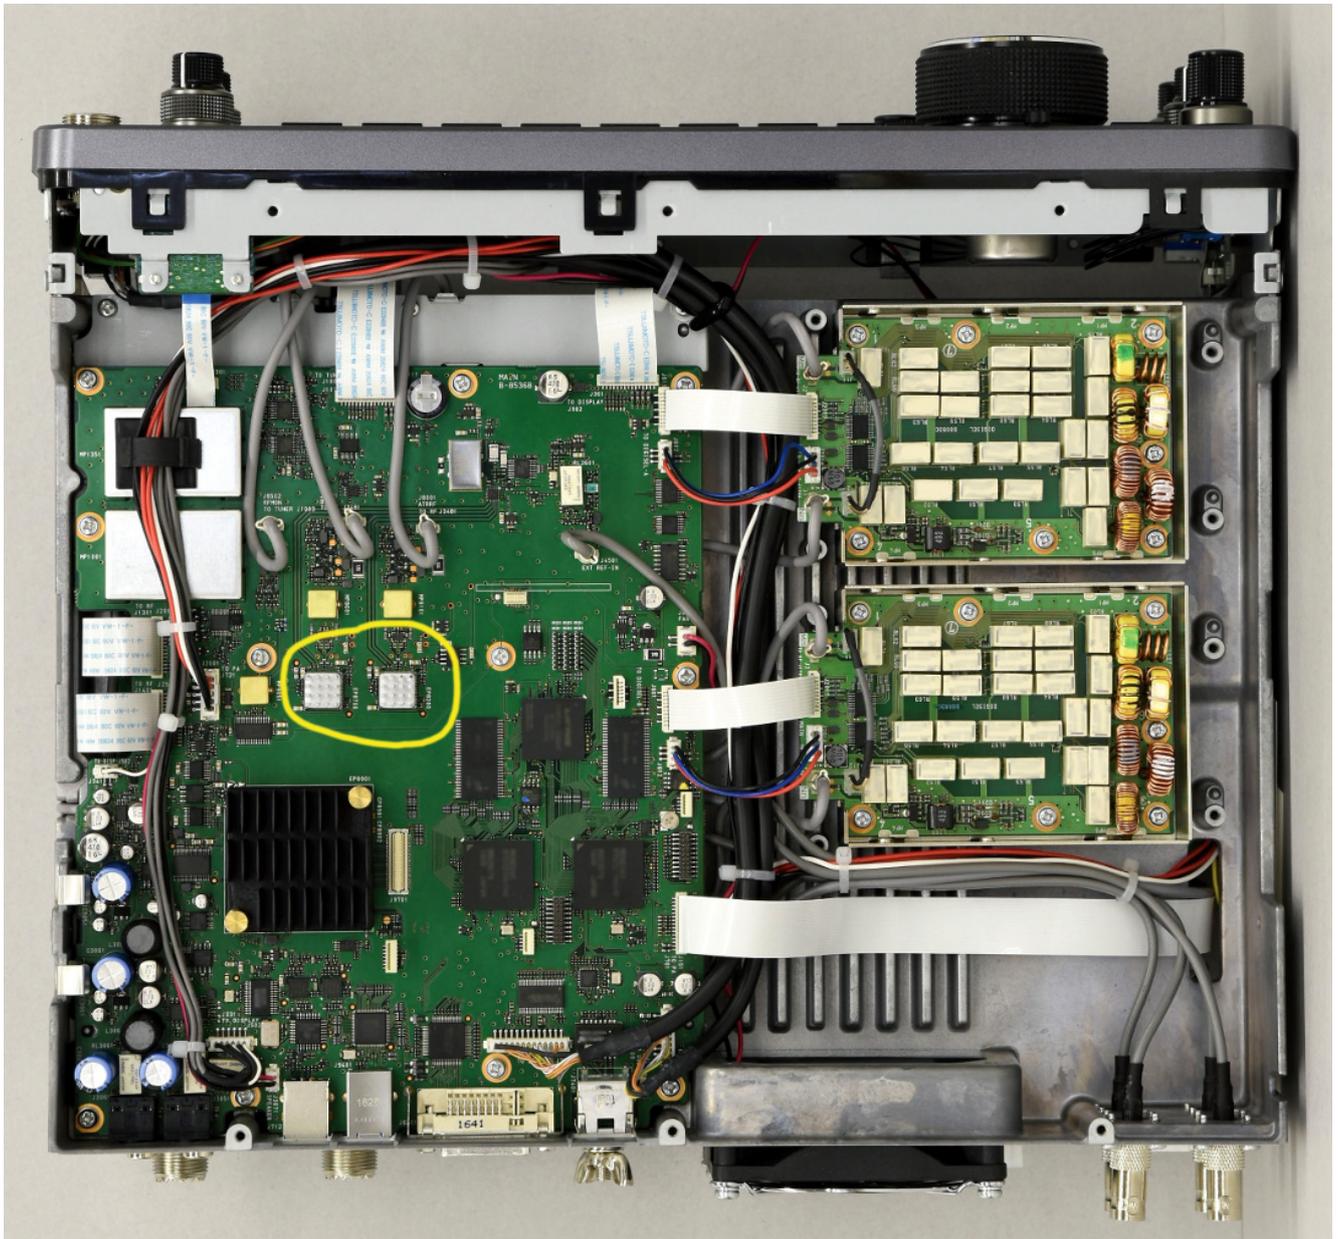
IC-7610 interior bottom view (courtesy Icom Inc.)

In this photo, this is what it should look like.
